VAPOUR INTRUSION Understanding Diffusion – The Often Overlooked Pathway

Mohamedarif Jagani
AiMS Environmental

SMART Remediation
Toronto, ON | January 24, 2019

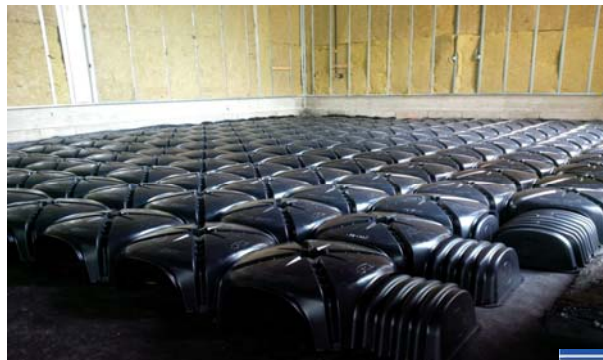
CASE STUDY: Guelph Commercial Devt Site: CUPOLEX® Blocks

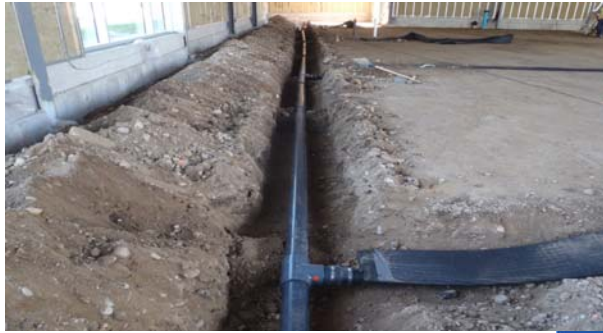
CASE STUDY: Guelph Commercial Devt Site:
Installation of Geovent® & Header System

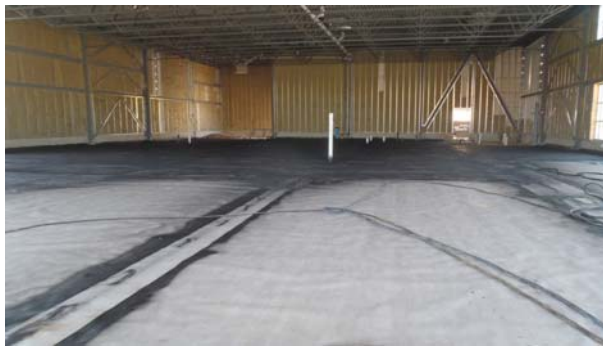
CASE STUDY: Guelph Commercial Site:
Carrier Geotextile Laid for Liquid Boot®

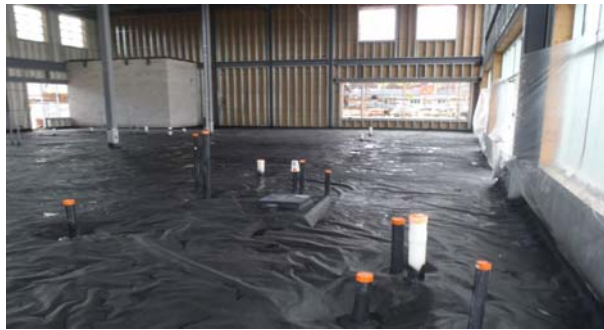
CASE STUDY: Guelph Commercial Devt Site:
Liquid Boot® Spray-Applied

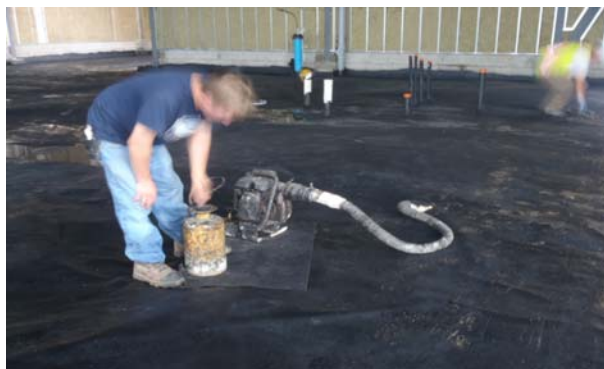
CASE STUDY: Guelph Commercial Site:
Smoke Testing Underway

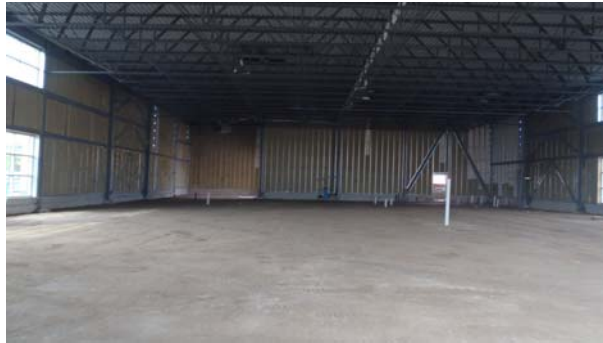
CASE STUDY: Guelph Commercial Devt Site: Concrete Slab Pour Completed

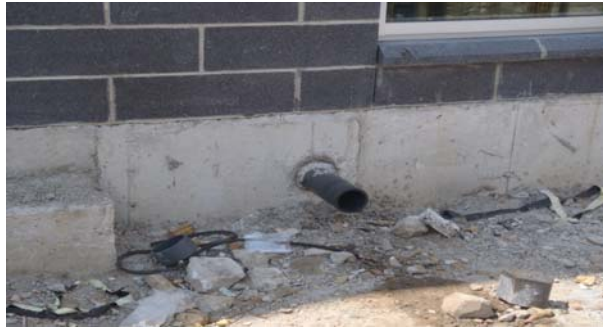
CASE STUDY: Guelph Commercial Site:
Subslab Air Monitoring Port - North

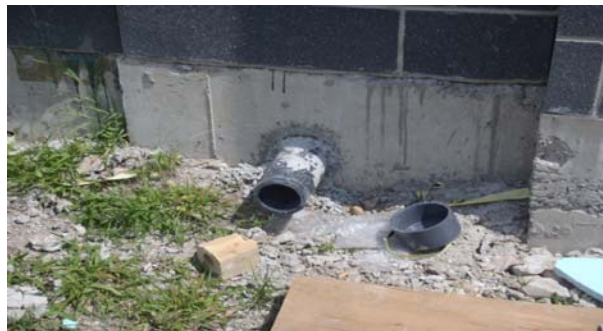
CASE STUDY: Guelph Commercial Site:
Subslab Air Monitoring Port - South

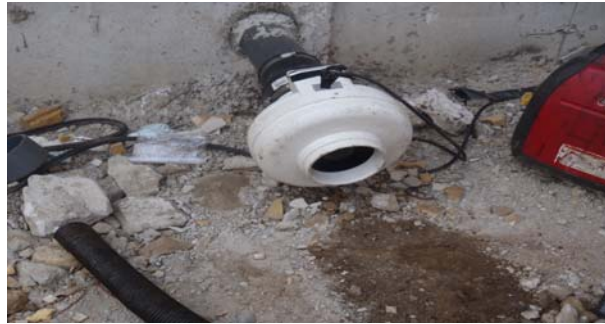
CASE STUDY: Guelph Commercial Site: Evacuation of SubSlab under CUPOLEX®

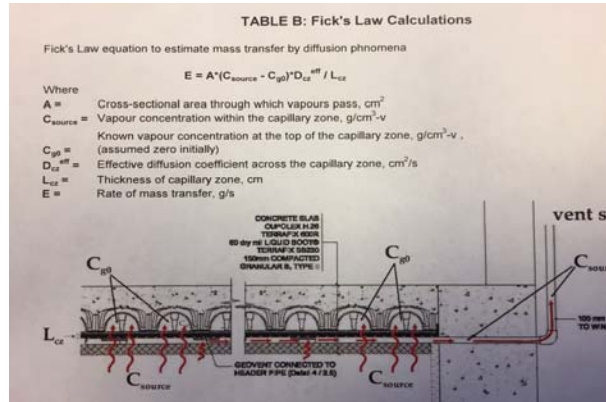
CASE STUDY: Guelph Commercial Site: Diffusion Calculations

Estimated Accumulation of Trichloroethylene in CUPOLEX Layer due to diffusion alone through Liquid Boot			
		Units	Calculations
A =	Area of Liquid Boot membrane (Area of Building B)	m^2	837.5
C_{source} =	Concentration of contaminant below Liquid Boot (Conc. in Geovent stack)	$\mu g/m^3$	249
C_{qb} =	Concentration of contaminant in Cupolex, Assumed to be zero	$\mu g/m^3$	0
D_{cz}^{eff} =	Effective diffusion coefficient of contaminant	m^2/s	9.07E-13
L_{cz} =	Thickness of Liquid Boot membrane	m	2.00E-03
E =	Rate of mass transfer	$\mu g/s$	9.45718E-05
	Estimated transfer of contaminant in Cupolex during one month	$\mu g/month$	245.1299922
V =	Volume of Cupolex layer (837.5*0.2)	m^3	167.5
	Estimated accumulation of contaminant in Cupolex during one month	$\mu g/m^3/month$	1.46E+00

So, in summary, the diffusion calculations predicted that at this site, upto $1.5 \mu g/m^3$ per month could be expected to accumulate in the CUPOLEX® layer by diffusion alone.
